Weather Station – Canterbury Cathedral

Case Study

Historic Building Condition Monitoring for Conservation

December 2017

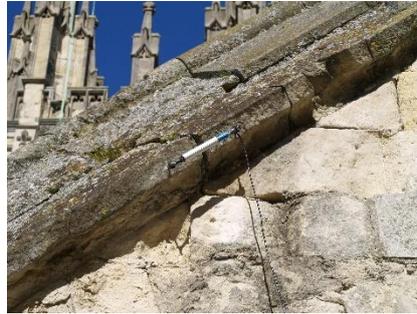
Crack sensing

information at points in and around the Cathedral. Structural monitoring now in place includes monitoring the movement in cracks or joints, using inclinometers to accurately measure the effect of wind loading and bells ringing in the main Bell Harry tower and piezo sensors in bore holes to measure the movement of the water table around the building.
